# UNDERWATER BRIDGE INSPECTION REPORT

STRUCTURE NO. 96271  
PEDESTRIAN WALKWAY  
OVER THE  
CANNON RIVER  
DISTRICT 6 - RICE COUNTY

PREPARED FOR THE  
MINNESOTA DEPARTMENT OF TRANSPORTATION  
BY  
COLLINS ENGINEERS, INC.  
JOB NO. 5221

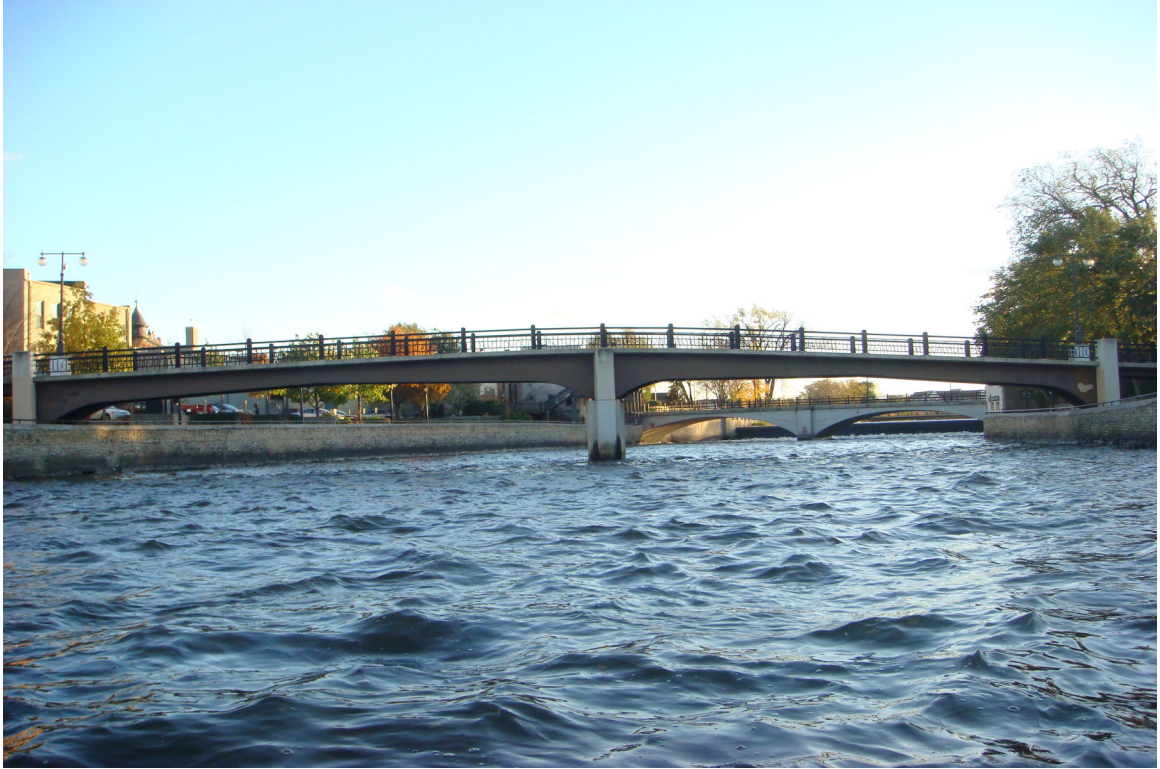
Photograph 1. Overall View of the Structure, Looking South.

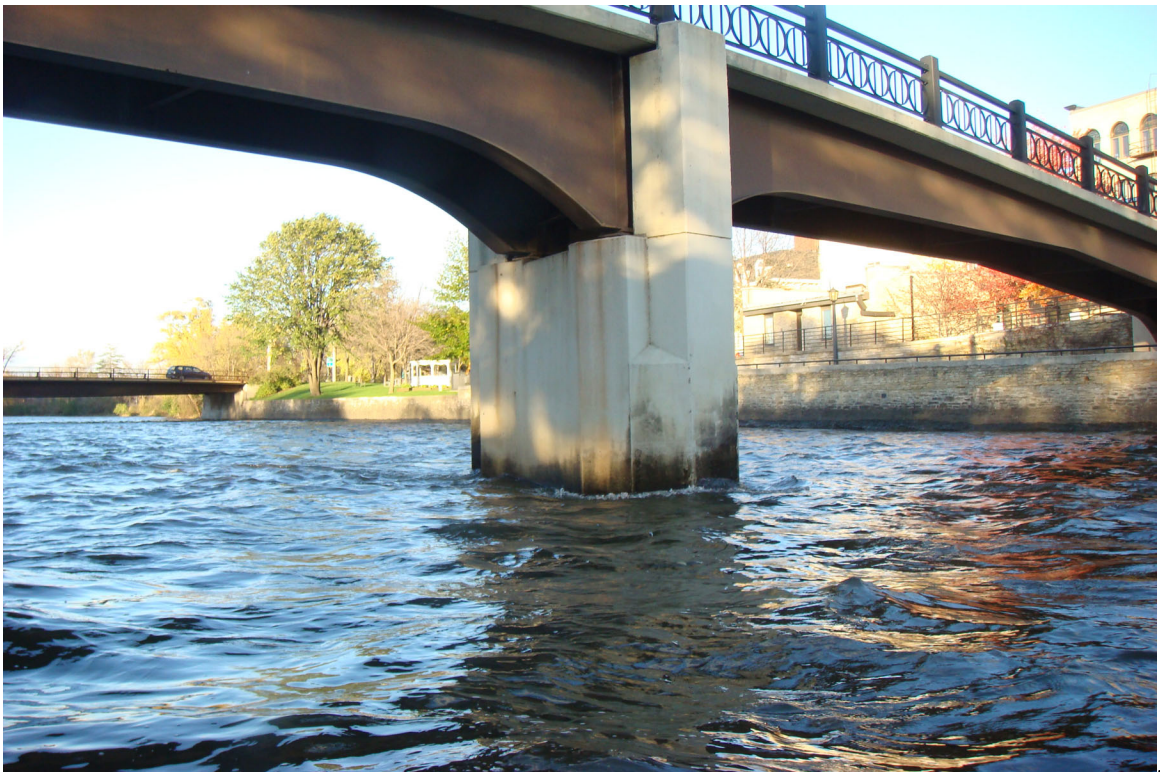
Photograph 2. View of the Center Pier, Looking Northeast.

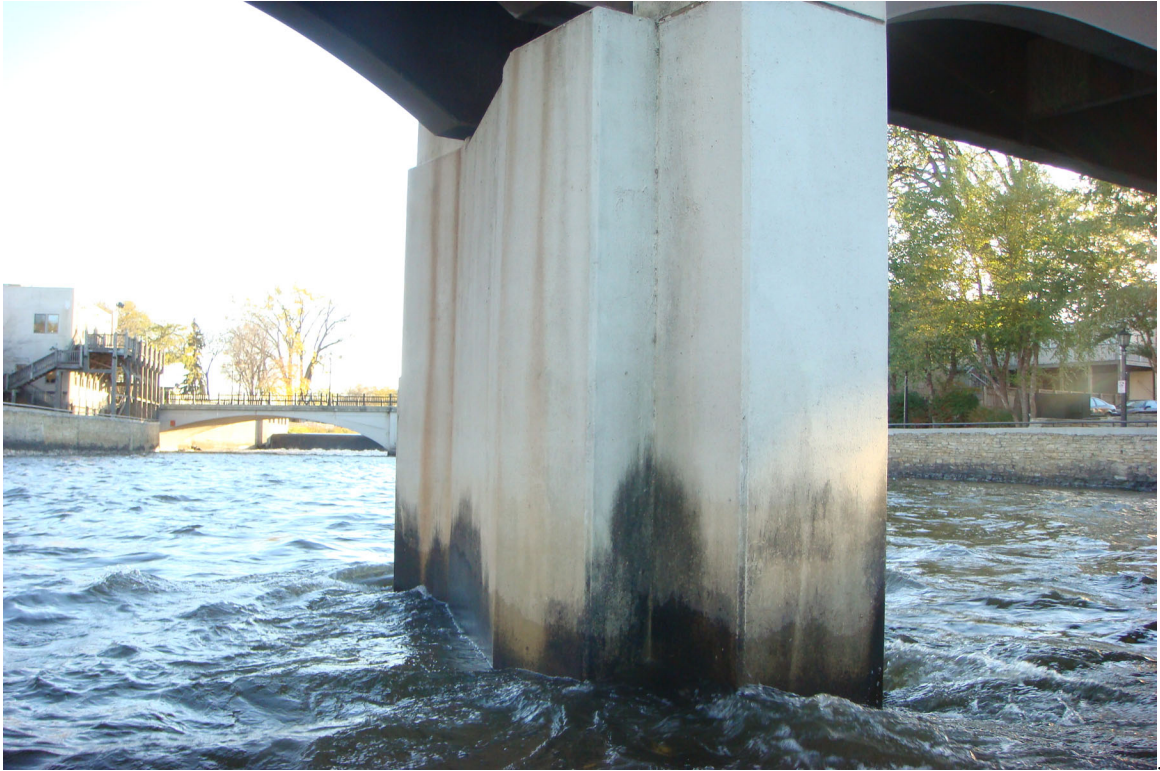
Photograph 3. View of the Center Pier, Looking Southwest.

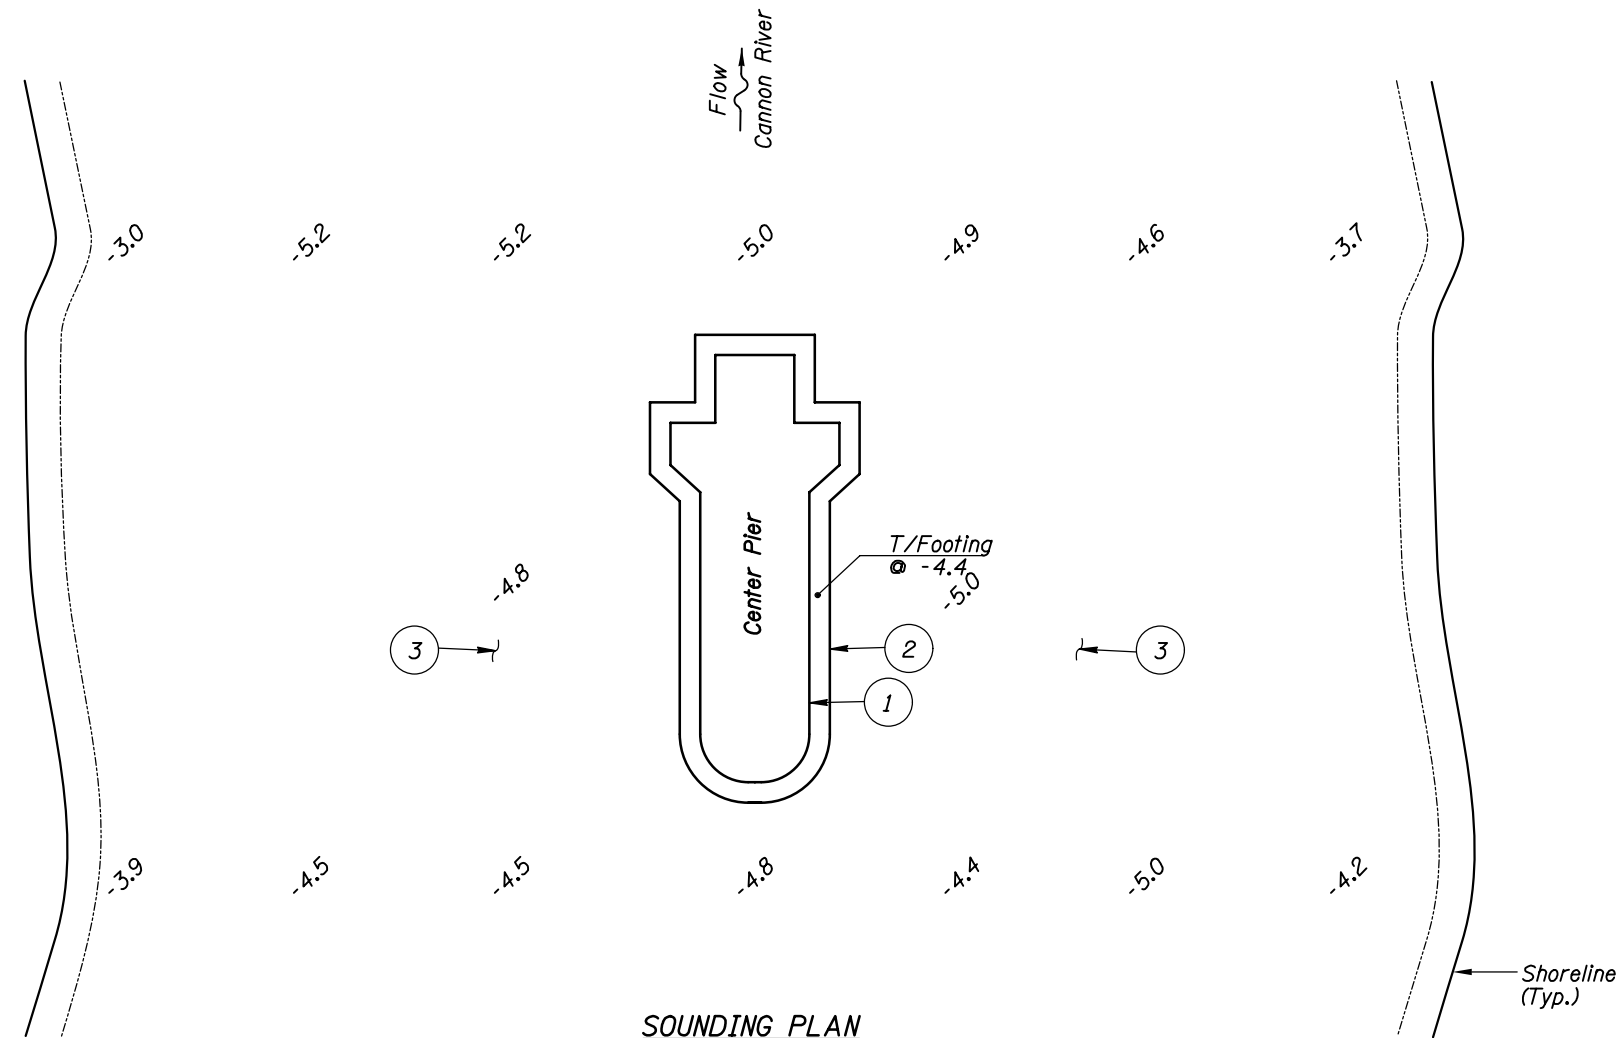
**INSPECTION AND SOUNDING PLAN**

- 1 Concrete was smooth and sound with no notable defects.
- 2 Footing exposure was observed at 4.4 feet below waterline around the entire pier with a maximum vertical exposure ranging from 0.4 to 0.6 feet.
- 3 Channel bottom consisted of rock with no probe rod penetration.

- (A) Monitor the footing exposure around the pier during future inspections.
- (B) Reinspect the submerged substructure units at the normal maximum recommended (NBIS) interval of five (5) years.
